SO 101.105 Komunikace - Demolice stávající komunikace / rekultivace

C.1 Objekty pozemních komunikací	Mřítko:	1:100
	Číslo zakázky:	56816.1-2
Příčné řezy - 1+700.00 - 2+000.00	Stupeň:	DPS
	Část: C.1.	Příloha: 5.5

Příčné řezy - 1+700.00 - 2+000.00

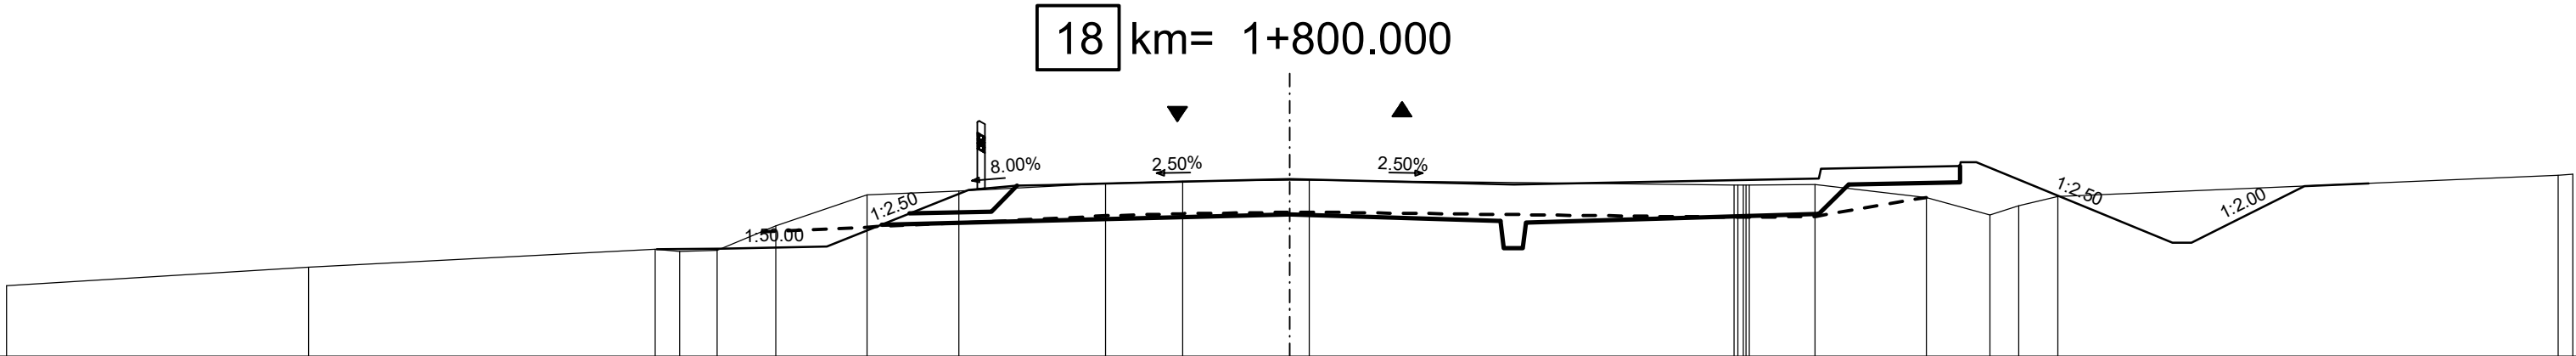
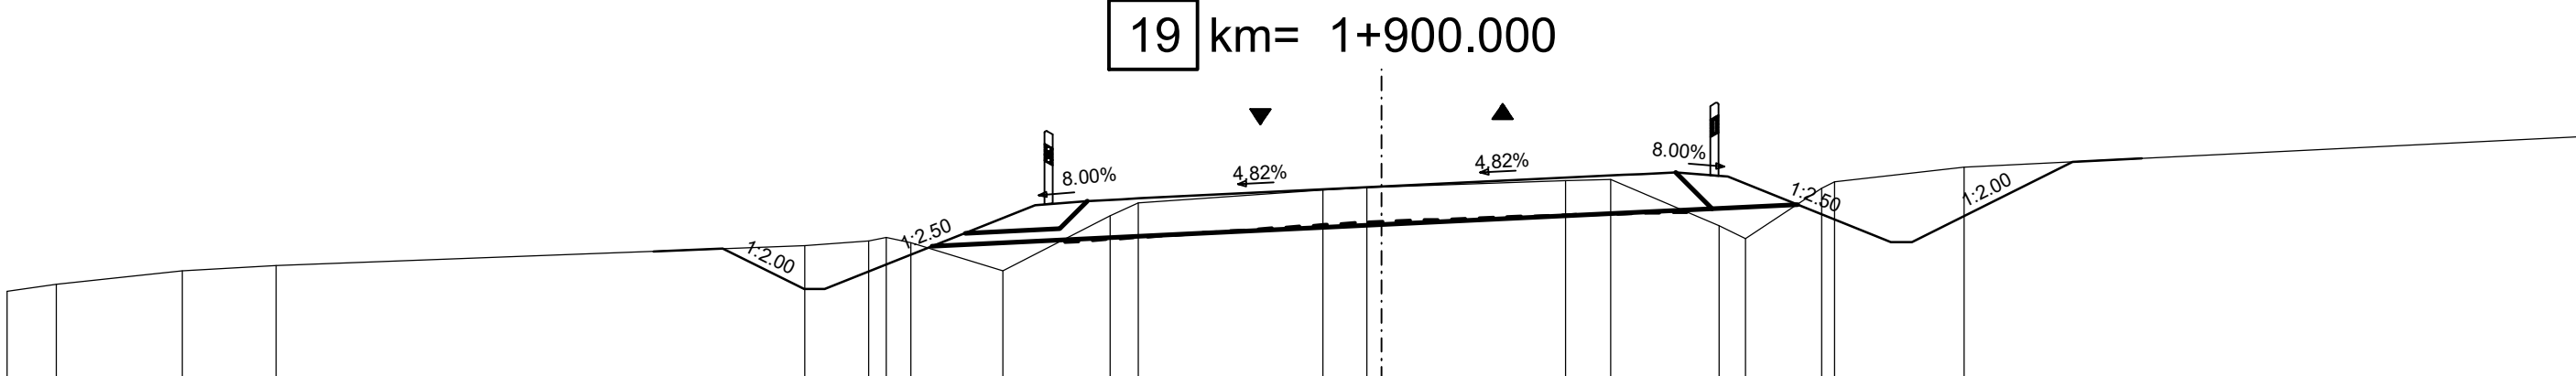
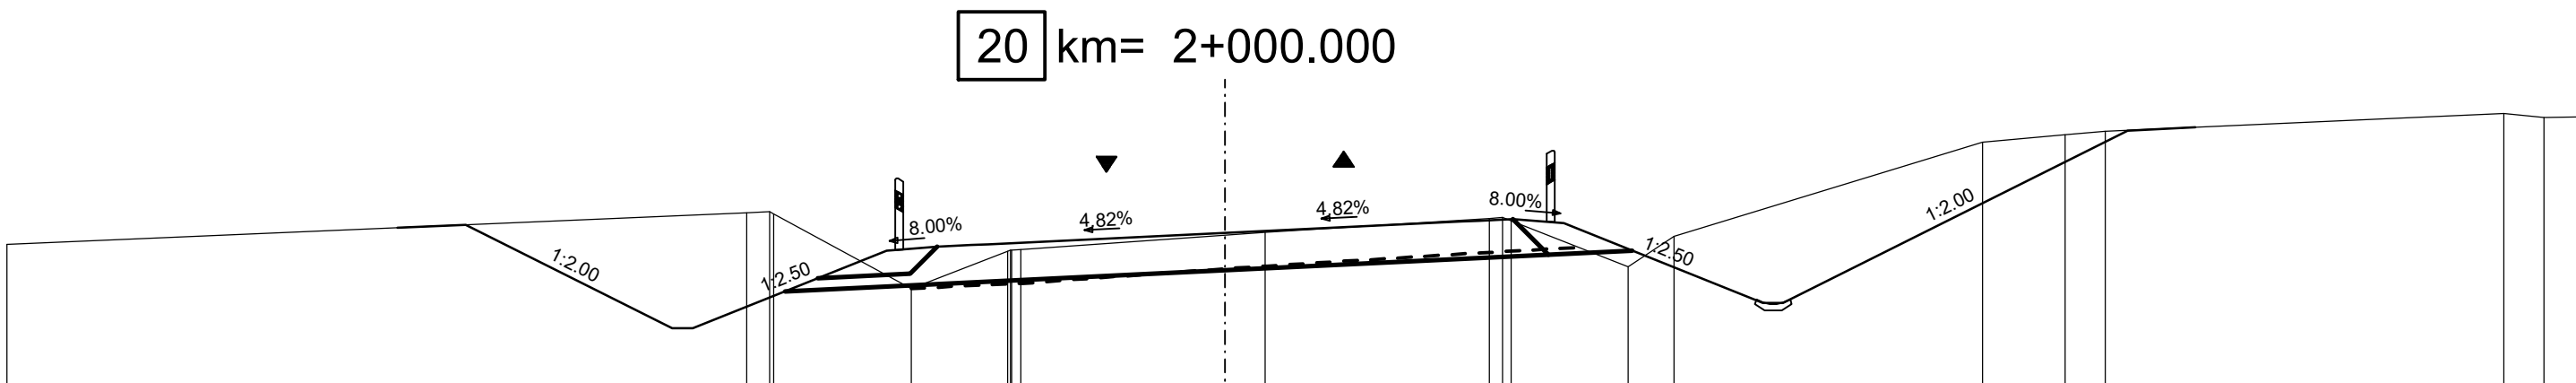
The diagram illustrates a cross-section of a road profile. The ground surface is shown as a solid line, and the proposed road grade is indicated by a dashed line. Key features include:

- Elevations:** The left side of the profile is at an elevation of 12.50. The right side of the profile is at an elevation of 12.00.
- Slopes:** The left side has a slope of 1:2.50. The right side has a slope of 1:2.00.
- Grades:** The central section of the road has a grade of 0.16% (indicated by a downward arrow) and 2.50% (indicated by an upward arrow).
- Drainage:** A drainage ditch is shown on the right side of the road, with a slope of 8.00%.
